## Installation of the kitchen stove

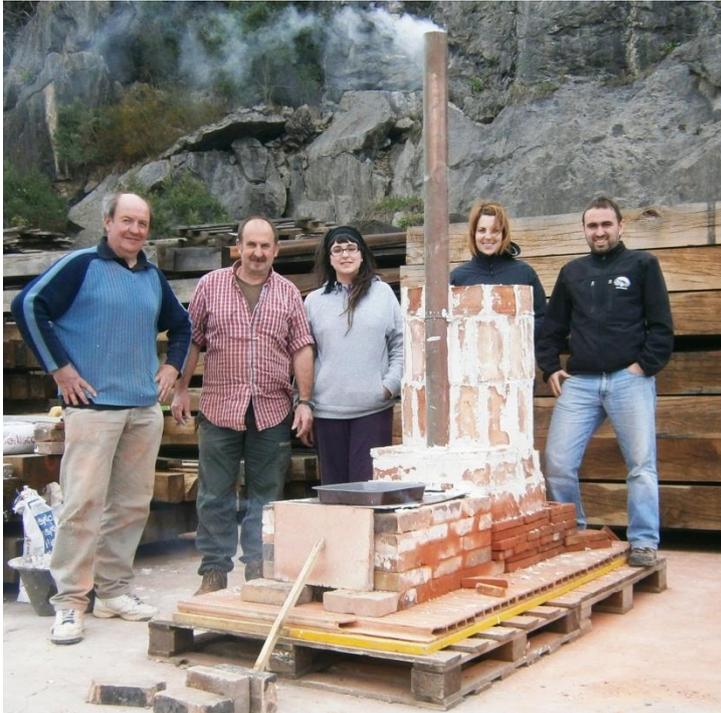
Everything was well sealed with plaster and the fire was lit. A lid was placed at the front to improve combustion.

After the process was complete, and the temperature and carbon dioxide levels had been measured, a number of conclusions were drawn:

If firebricks are not used throughout the construction, as was done at Igartubeitti, the stove will not retain all the heat possible. Furthermore, the metal sheet allows heat to escape instead of being retained. To overcome this, Karmelo Bizkarra advised making a hole in the bricks to fit the pan which would then be in direct contact with fire, making the most the available heat.
